# Environmental and Public Health Risks Associated with Household Cesspits in the Gaza Strip, Palestine, under Israel's Ongoing War of Genocide and Ethnic Cleansing (2023–2026)

## ABSTRACT

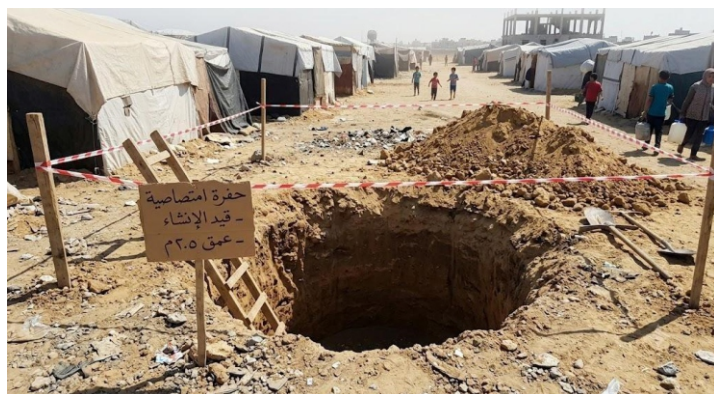
Unlined excavation pits represented the simplest and most rapidly constructed sanitation systems in temporary displacement areas (**Figure 3**). These pits were excavated directly into natural soils, particularly sandy and sandy-calcareous (kurkar) formations, allowing partial infiltration of wastewater into surrounding soil layers. In areas characterized by clay-rich soils or shallow groundwater tables, however, infiltration capacity was limited, resulting in rapid filling, frequent overflow, and increased risks of environmental contamination.

**Figure 3:** Unlined pits are the simplest and quickest type of cesspit constructed in the Gaza Strip, especially in temporary displacement areas

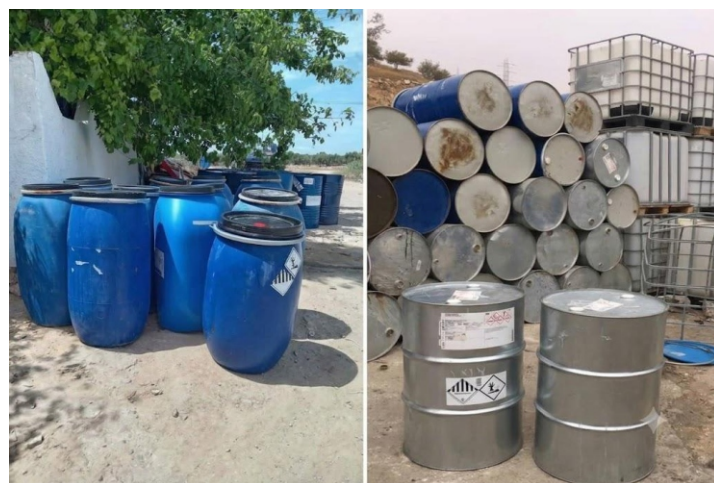
Metal-barrel systems typically comprised two or more stacked 200-L barrels with removed bottoms and lateral openings to enhance seepage. Although these systems were inexpensive and rapidly installed, their limited storage capacity, structural deterioration, corrosion (in metal barrels), and uncontrolled leakage substantially reduced their effectiveness and increased risks of soil and groundwater contamination.

Metal- and plastic barrel-based systems were commonly used as low-cost emergency sanitation solutions where conventional construction materials were unavailable. These systems consisted of buried recycled barrels or plastic containers connected to household wastewater discharge pipes (Table 1). In many installations, the bases and sidewalls were perforated to facilitate infiltration into surrounding soils.

**Figure 4:** Various used plastic and metal barrels are sometimes utilized as structural components in the construction of household cesspits in the Gaza Strip

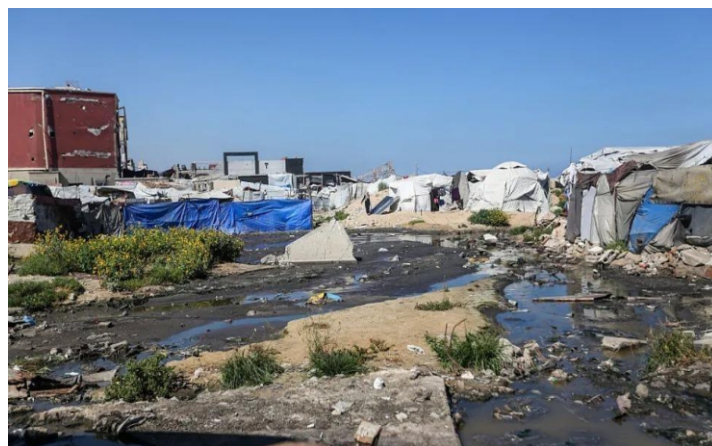
Frequent overflow of household cesspits was widely documented across densely populated residential areas and displacement camps following the deterioration of sanitation services (Figure 5). Overflowing cesspits discharged untreated domestic wastewater into streets, agricultural lands, public spaces, and around temporary shelters, resulting in widespread surface contamination and environmental degradation. Wastewater accumulation was repeatedly observed adjacent to residential buildings, displacement tents, and public facilities, creating continuous exposure pathways for humans, domestic animals, and surrounding ecosystems. The uncontrolled release of untreated wastewater introduced substantial quantities of organic matter, nutrients, suspended solids, pathogens, and household chemicals into terrestrial environments. Field observations further documented soil degradation, persistent foul odors, proliferation of flies and commensal rodents, and deterioration of living conditions in affected communities. In agricultural areas, wastewater leakage created additional concerns regarding crop contamination and pathogen transmission.

*Figure 5: Overflowing cesspits in displacement camps have resulted in uncontrolled discharge of untreated wastewater, causing surface contamination, soil degradation, foul odors, insect and rodent proliferation, deterioration of living conditions, and increased risks of exposure to pathogenic microorganisms and waterborne diseases*

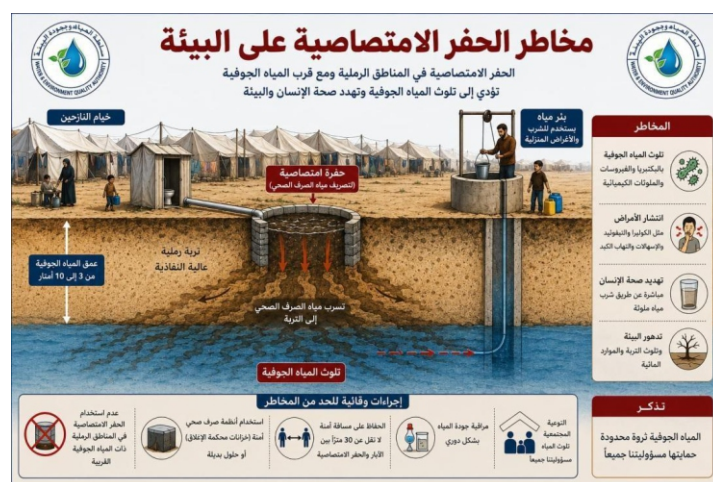
**Figure 10: Arabic-language awareness poster issued by the Water and Environment Quality Authority in the Gaza Strip highlighting the environmental risks of household cesspits, particularly groundwater contamination**

Leakage from cesspits may introduce fecal indicator bacteria, pathogenic microorganisms, nutrients, organic pollutants, and household chemical residues into the aquifer, posing significant environmental and public health concerns. The deterioration of sanitation infrastructure further intensified these risks by increasing wastewater retention times, reducing safe disposal options, and expanding the number of overloaded cesspits. The proximity of many household cesspits to domestic wells further increases groundwater vulnerability. Reflecting these concerns, the Water and Environment Quality Authority in the Gaza Strip recently issued a public awareness poster highlighting the risks of cesspit-derived groundwater contamination (Figure 10).
